REPORT
OF
THE BOARD OF INQUIRY
into the accident at
Toronto International Airport,
Malton, Ontario,
to Air Canada DC8-CF-TIW aircraft
on July 5, 1970
held before
The Honourable Mr. Justice Hugh F. Gibson,
Commissioner.

to Air Canada DC8-CF-TIW aircraft

on July 5, 1970

Commissioner.

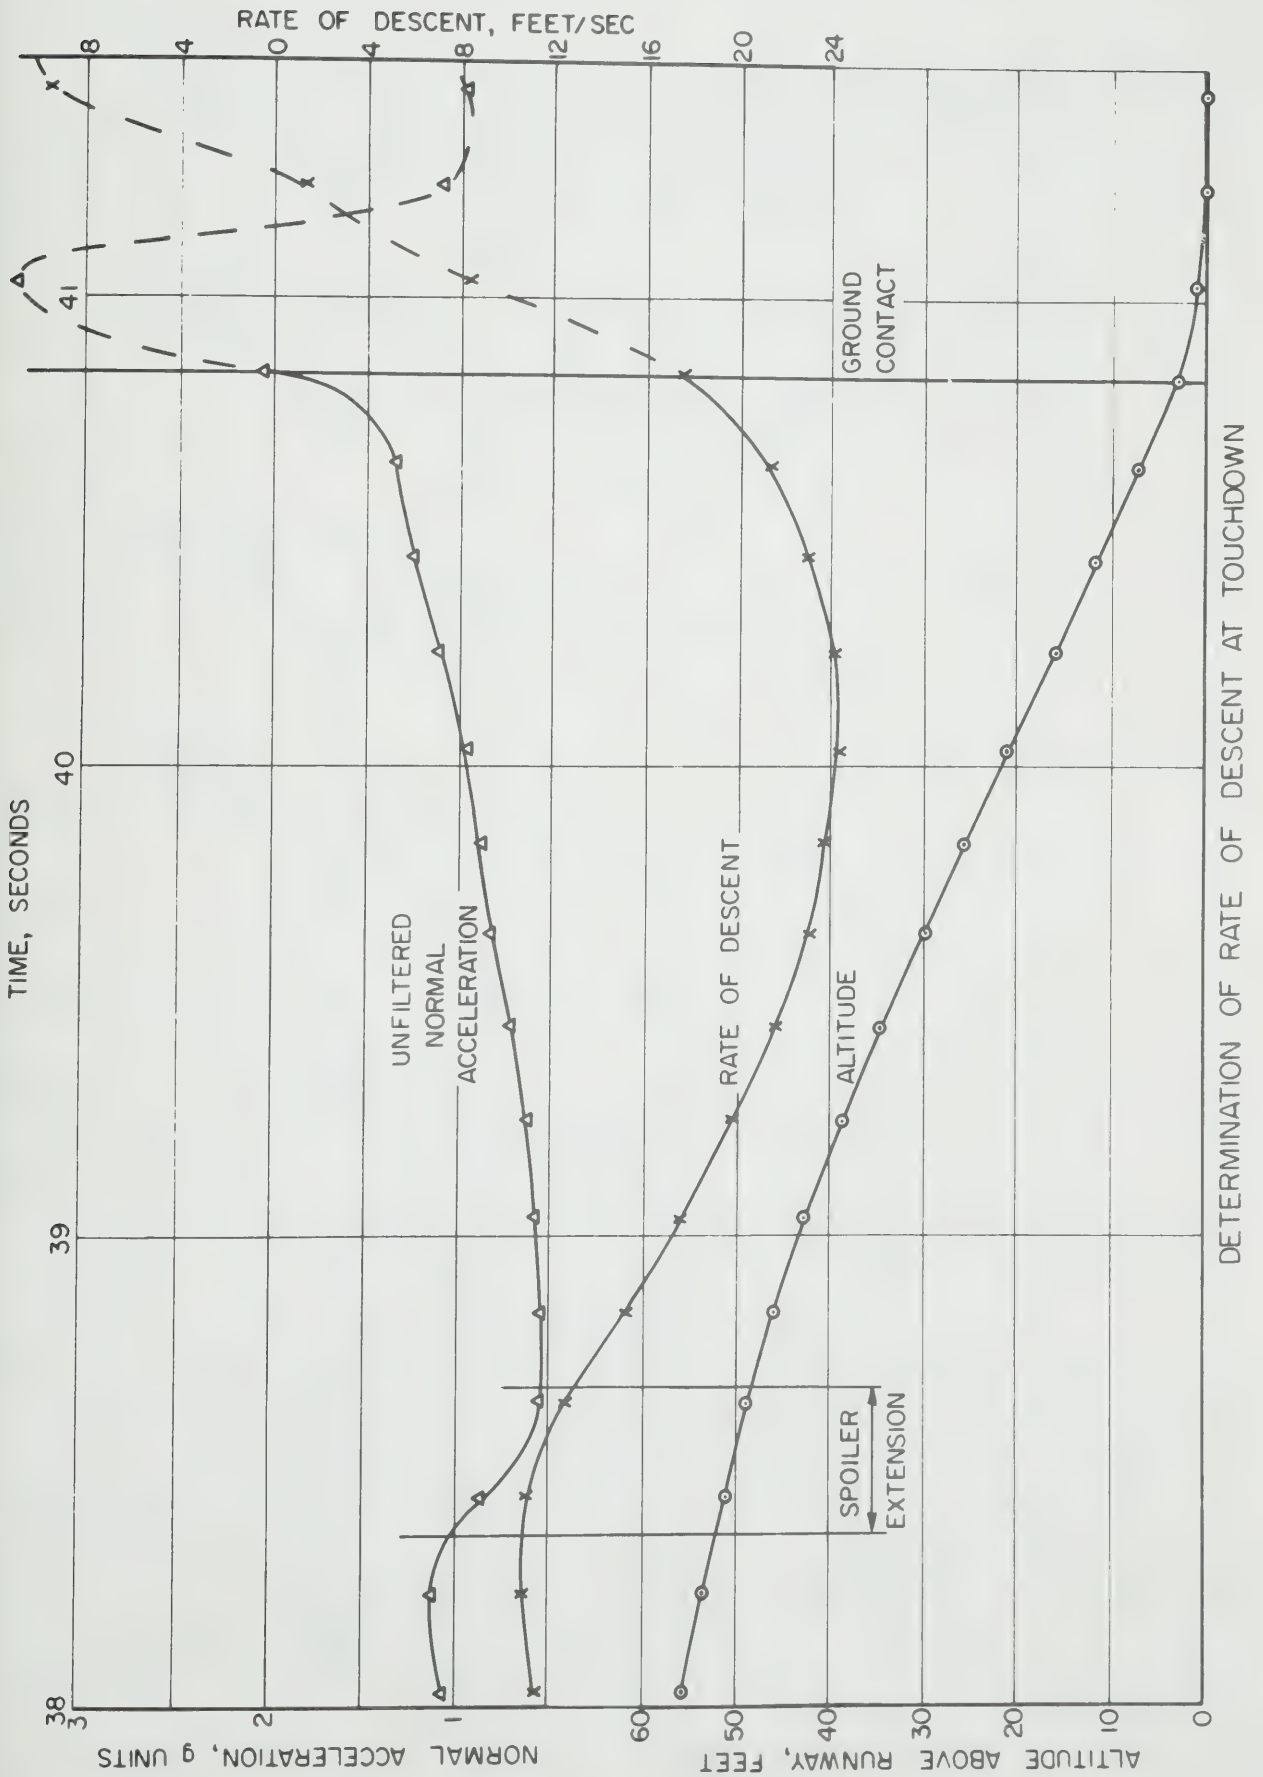
SCHEDULE 5 OF APPENDIX D

VARIAION OF CRITICAL PARAMETERS DURING SPOILER DEPLOYMENT AND TOUCHDOWN
WITH SYNCHRONIZED VOICE INFORMATION

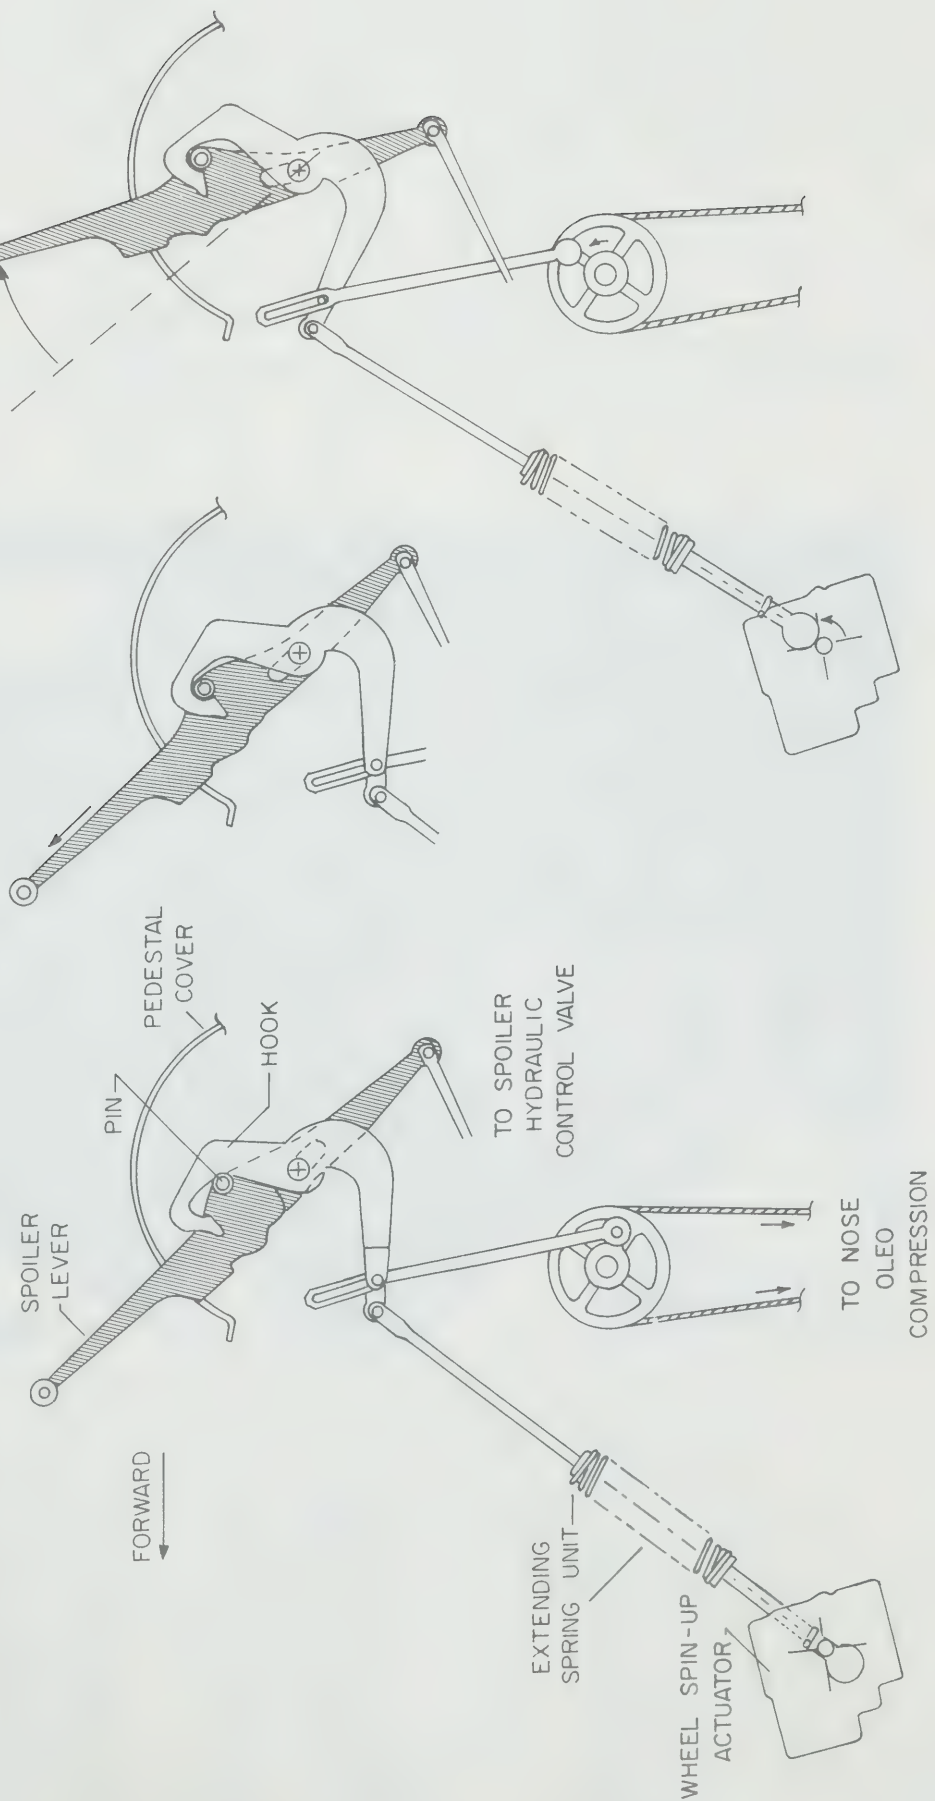
SCHEDULE 14 OF APPENDIX D
 SKETCH OF DETAILS OF PYLON TO WING ATTACHMENT FITTINGS

NORMAL CONFIGURATION
 IN FLIGHT BEFORE ARMING.
 SPOILERS RETRACTED

NORMAL CONFIGURATION
 ON APPROACH. SPOILER
 LEVER ARMED TO
 ENGAGE PIN IN HOOK.

NORMAL CONFIGURATION
 AFTER TOUCHDOWN.
 SPOILERS EXTENDED BY
 AUTOMATIC ACTUATION
 HOOK AND LEVER
 IN AFT POSITION.

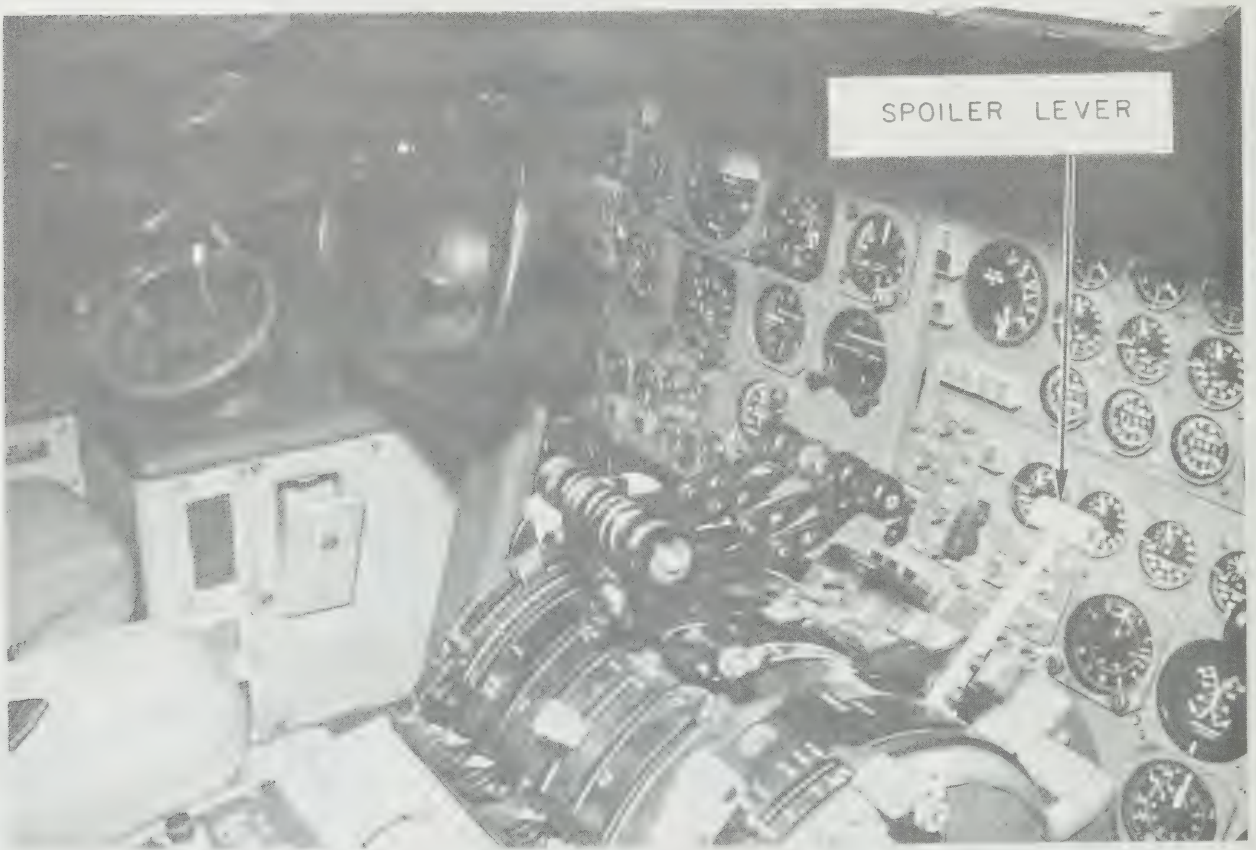
SCHEDULE 15 OF APPENDIX D
PHOTOGRAPH OF PEDESTAL IN DC-8-63 SHOWING GROUND SPOILER LEVER

Immediately thereafter the First Officer instead of arming the ground spoilers by lifting up the knob of the spoiler actuating lever, pulled the lever aft to the aft extend position, which caused the ground spoilers to be deployed immediately thereafter. As a result, the aircraft lost lift immediately and developed a vertical acceleration of approximately (-) $\frac{1}{2}g$.
